Manhole Inspection Summary

Manhole # S49GG_027MH

Insp Date: **8/11/08 8:30 AM**

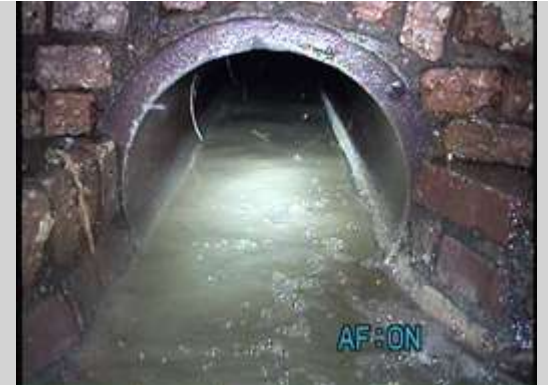
12 O'Clock Outflow

15 in. Circular Gravity Sewer
Pipe Out @ 12 O'Clock

Pipe Height: **15.6** (in.) Rod and Bar (Angled)
Pipe Material: **Clay** ☐ Pipe Lined
Invert Depth: **13.30** (ft.) Flow Characteristics: **Fast**
Deposits: ☒ None ☐ Mud ☐ Sludge ☐ Debris ☐ Grease
Silt Depth: (in.) Deposits Extent:
Infiltration: **None** Pipe Seal Cond: **Sound**

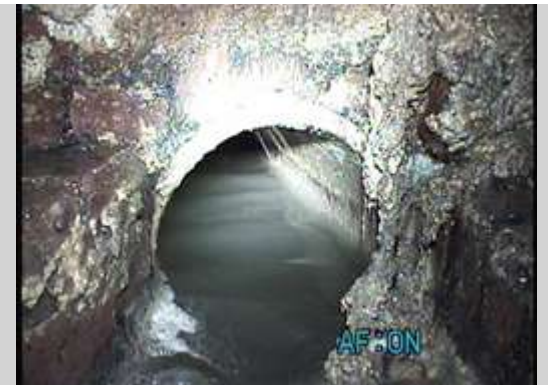
3 O'Clock Inflow

12 in. Circular Gravity Sewer
Pipe In @ 3 O'Clock

Pipe Height: **12** (in.) Rod and Bar (Angled)
Pipe Material: **Clay** ☐ Pipe Lined
Invert Depth: **13.20** (ft.) Flow Characteristics: **Fast**
Deposits: ☒ None ☐ Mud ☐ Sludge ☐ Debris ☐ Grease
Silt Depth: (in.) Deposits Extent:
Infiltration: **None** Pipe Seal Cond: **Sound**

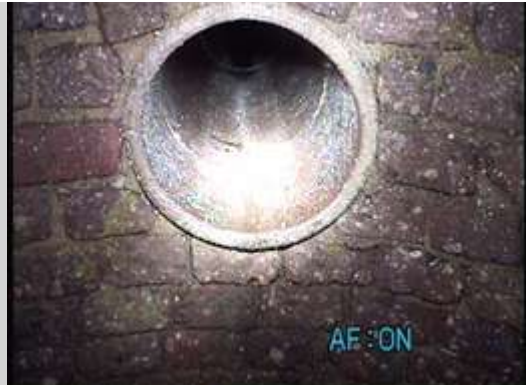
6 O'Clock Inflow

8 in. Circular Gravity Sewer

Pipe In @ 6 O'Clock

Pipe Height: **8.4** (in.) Rod and Bar (Angled)

Infiltration: **None** Pipe Seal Cond: **Sound**

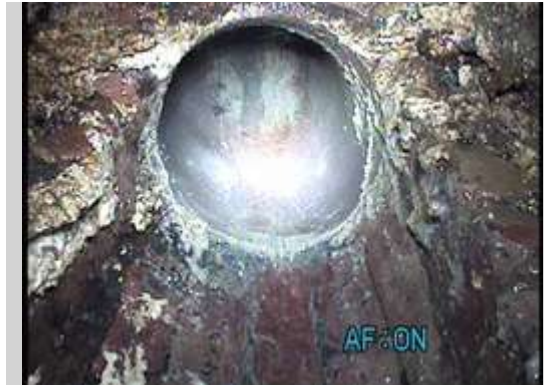
Drop In @ 6 O'Clock

Drop: **Outside** Rod and Bar
Angled: **Yes** Reading: **11.50** (ft.)
Inv Depth: **12.50** (ft.)
Drop Condition: **Open**

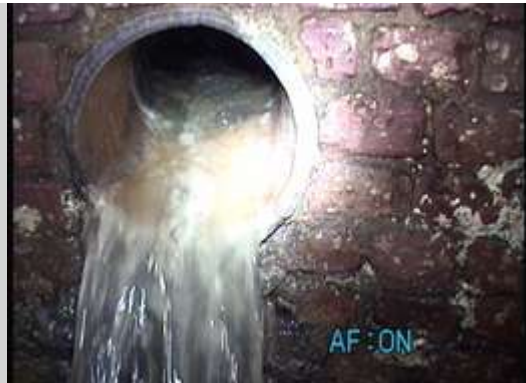
9 O'Clock Inflow

8 in. Circular Gravity Sewer

Pipe In @ 9 O'Clock

Pipe Height: **8.4** (in.) Rod and Bar (Angled)

Infiltration: **None** Pipe Seal Cond: **Sound**

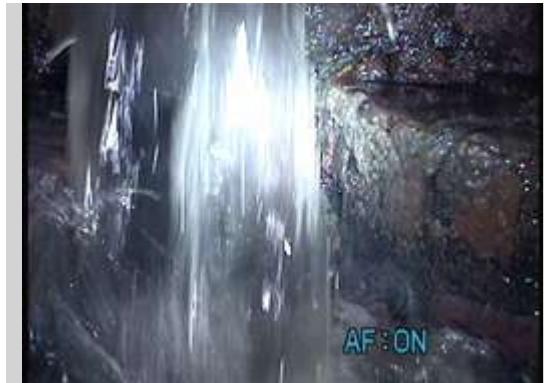
Drop In @ 9 O'Clock

Drop: **Outside** Rod and Bar
Angled: **Yes** Reading: **11.90** (ft.)
Inv Depth: **12.90** (ft.)
Drop Condition: **Open**
